**TRANSPORTATION SCIENCES CENTER
ACCIDENT RESEARCH GROUP**

CALSPAN REMOTE AIR BAG DEPLOYMENT INVESTIGATION

CALSPAN CASE NO. 93-7

VEHICLE - 1993 VOLVO 850 GLT

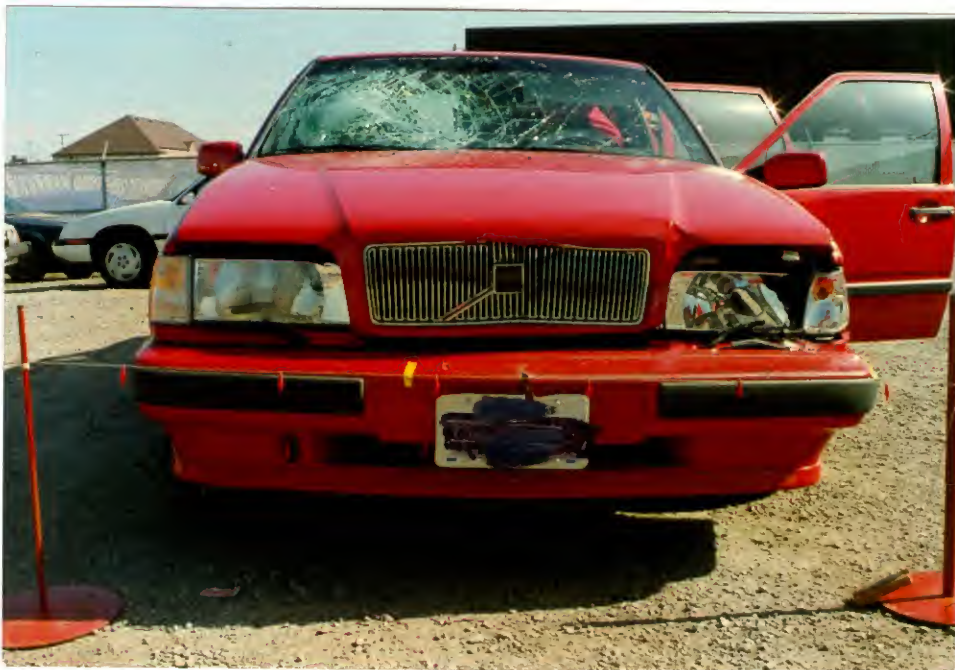
9

The frontal area of the Volvo 850 GLT sustained minor damage from its impact sequence with the rear of vehicle #2. The upper face of the front bumper fascia initially contacted the rear bumper of vehicle #2 then subsequently underrode the Volkswagen's bumper. As a result, the Volvo sustained crush damage to the hood face, grille, and left headlamp area.

Direct contact damage began 18.5 cm (7.3") right of center and extended 97 cm (38") to the left front corner. Contact damage on the bumper fascia consisted of abrasions and black rubber/plastic transfers and a vertically orientated tear at the mid portion of the fascia. There was no residual crush to the bumper system. The Volvo was not equipped with a conventional hydraulic bumper energy absorbing system. The leading ends of the front frame rails consisted of a deformable convoluted energy absorption system with two V-shaped convolutions at each rail. The outboard convolutions were 7.0 cm (2.8") in width while the inboard convolutions were 2.5 cm (1.0"). These vertically orientated convolutions were not compressed or displaced laterally and appeared to be in factory-original condition.

Frontal Damage to the Volvo 850 GLT

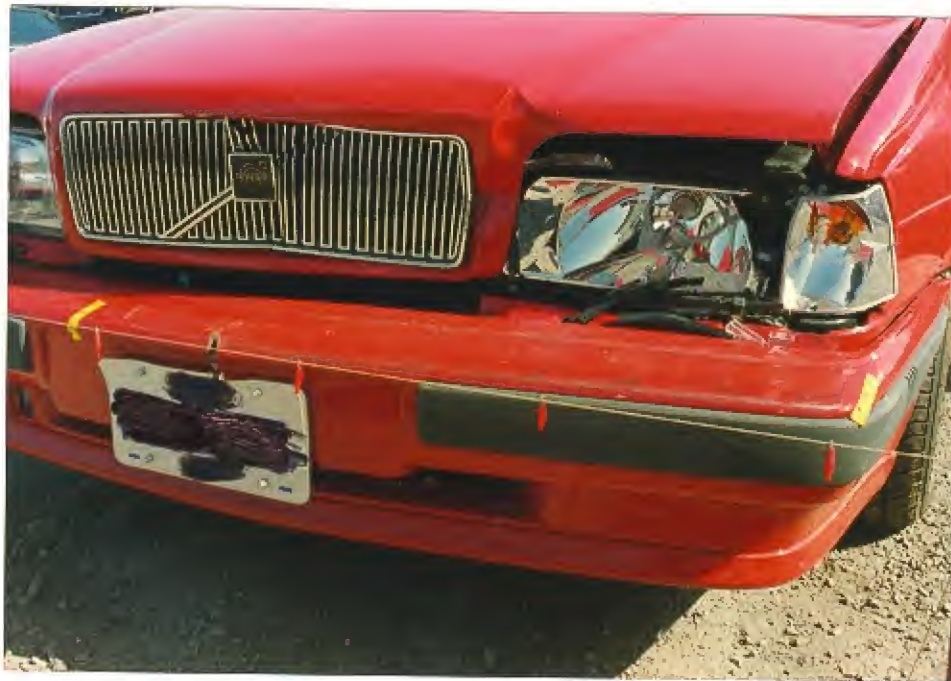
10

<u>Air Bag Vehicle</u>	<u>Vehicle #2</u>
Exterior (Cont'd.):	<p>The damage to the hood face, grille, and headlamp components resulted from contact with the rear bumper of the Volkswagen Golf. The sheetmetal deformation began at the right hood face, directly inboard of the right headlamp assembly. The direct contact damage extended laterally 109.2 cm (43.0") to the left turn signal lens. Although no structural components were involved, the sheetmetal crush values at grille level were as follows:</p> <p>$C_1 = 3.8 \text{ cm (1.5")}$, $C_2 = 5.8 \text{ cm (2.3")}$, $C_3 = 6.4 \text{ cm (2.5")}$, $C_4 = 1.3 \text{ cm (0.5")}$, $C_5 = 0 \text{ cm}$, $C_6 = 0 \text{ cm}$.</p> <p>Components damaged by the minor severity crash included the front bumper fascia, license plate, hood and hood face, grille, left headlamp and turn signal assemblies, the left front fender, and a superficial crack of the plastic cowl that extends across the upper radiator support panel.</p>	<p>Damaged components included the rear bumper, right bumper EAD, the sheetmetal above and below the bumper, and slight induced damage to the right rear quarter panel.</p>

Close-up View of the Frontal Damage

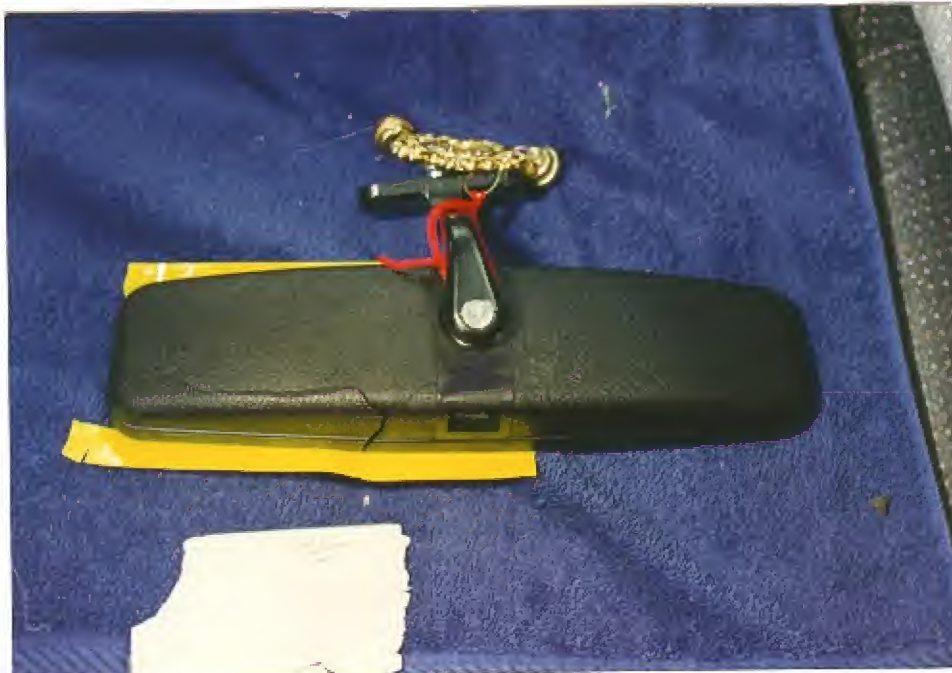
35

Mirror Damage that Resulted from the Child Occupant's Head Impact

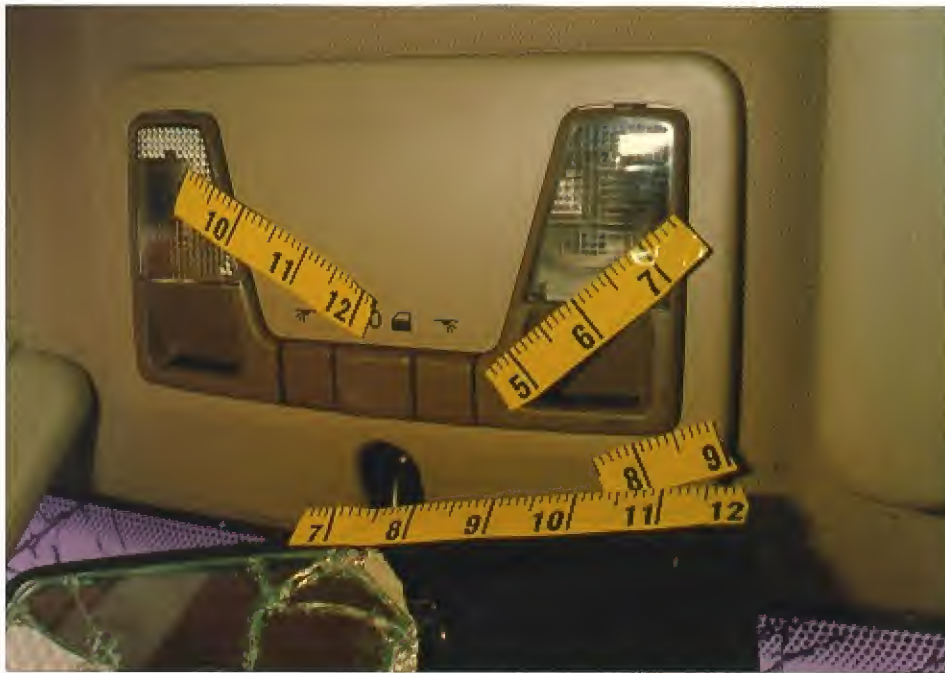
36

Mirror was Displaced into the Map Light Console on the Roof and Disengaged from the Mount

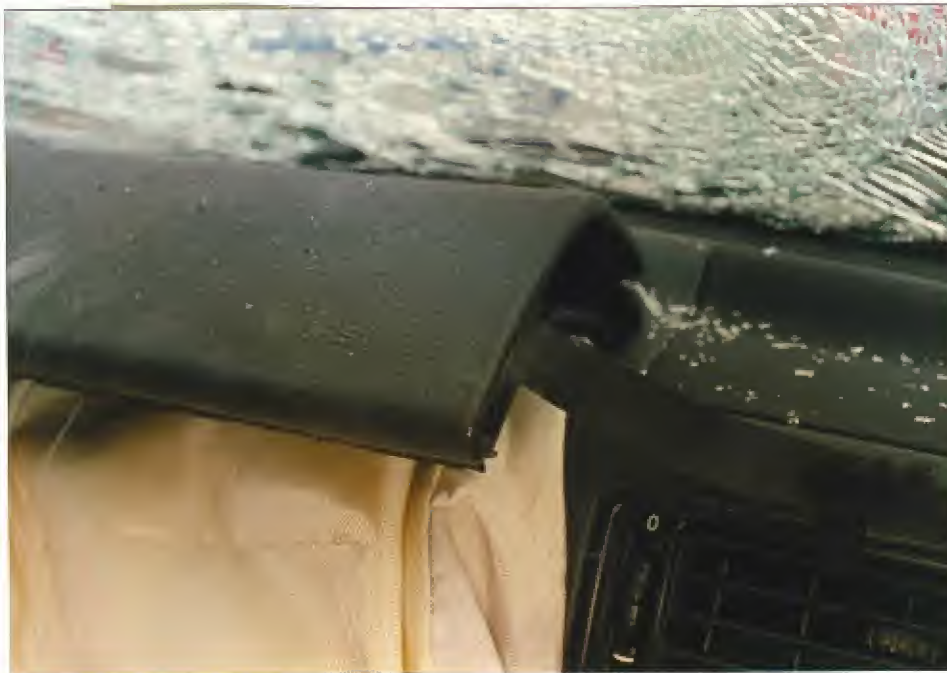
37

Right Corner of the Passenger Air Bag Module Cover Flap Impacted and Cracked the Windshield; Right Tether (Limiter) Strap for the Module Cover Flap Separated

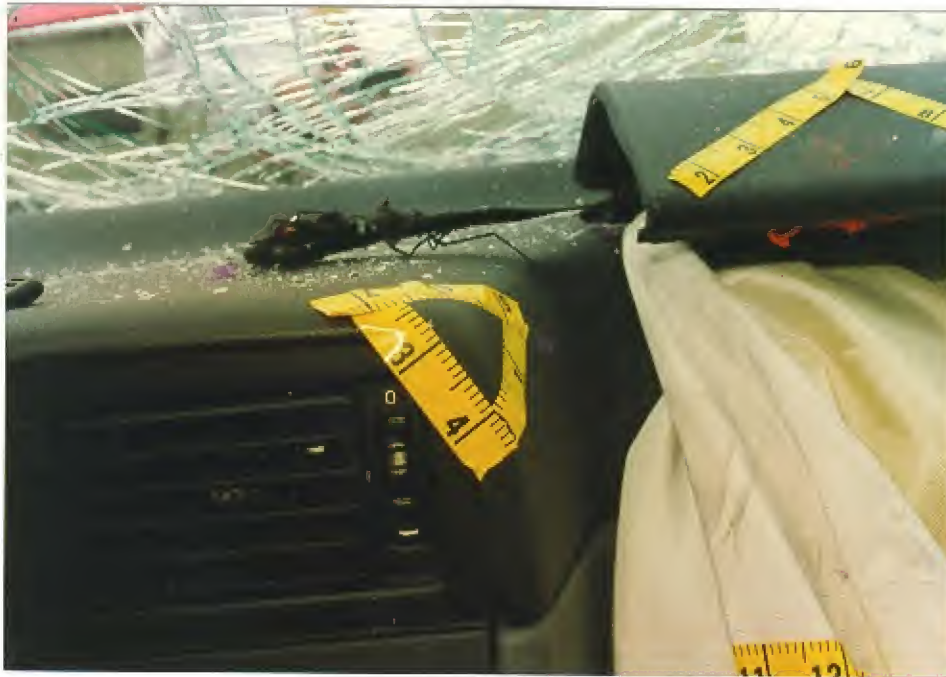
38

Left Module Cover Tether Strap Separated

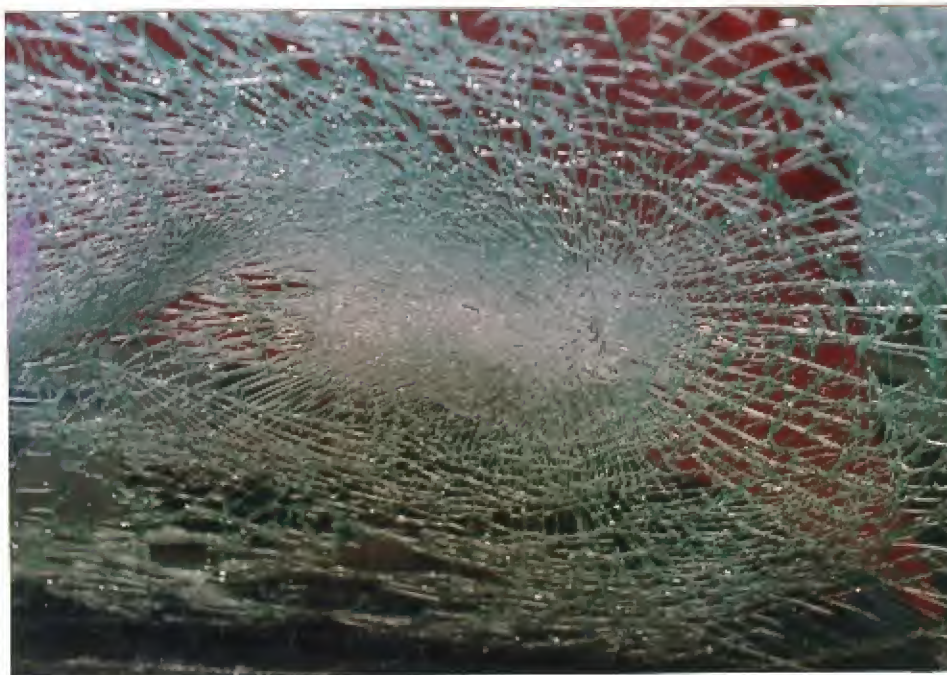
39

Windshield Impact Area from Passenger Air Bag Module Cover Flap,
Vinyl Transfers Embedded into Broken Glass

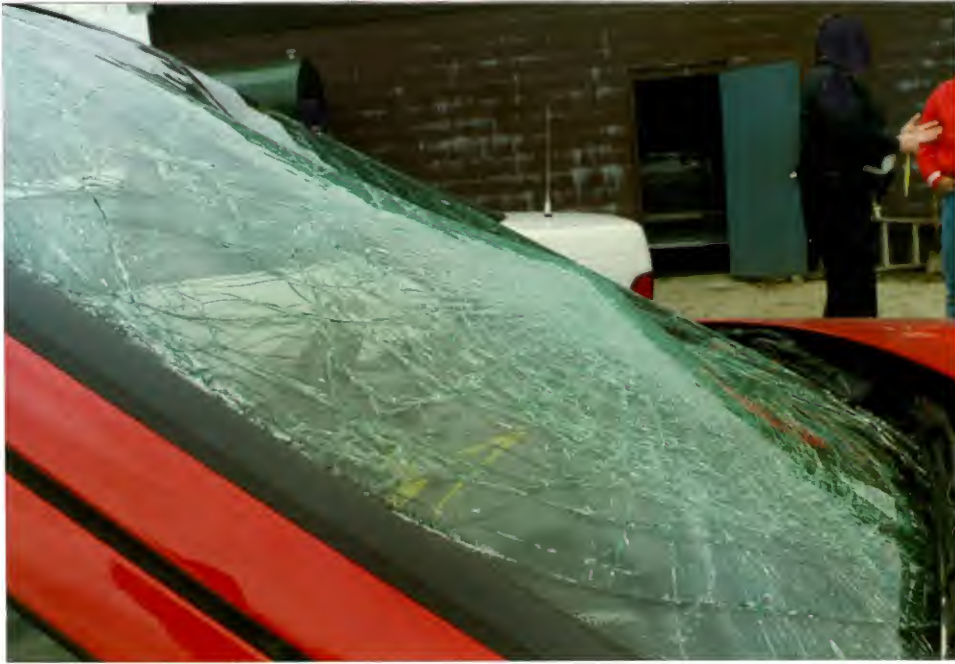
40

6.4 cm (2.5") of Outward Bowing to Windshield from Module Cover Flap Contact

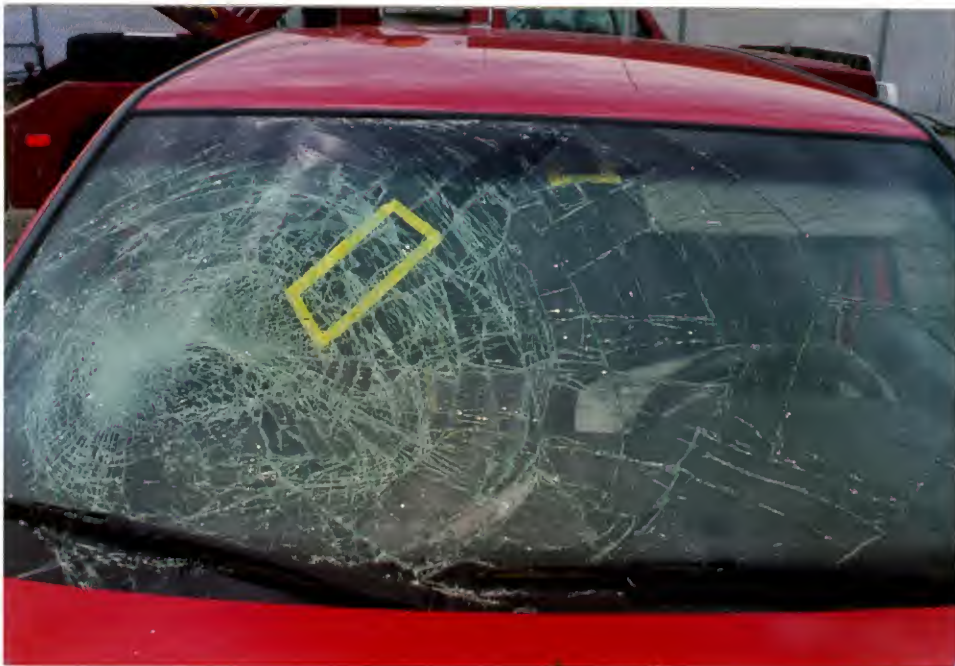
41

Damage to Windshield that Resulted from Module Cover Flap Contact

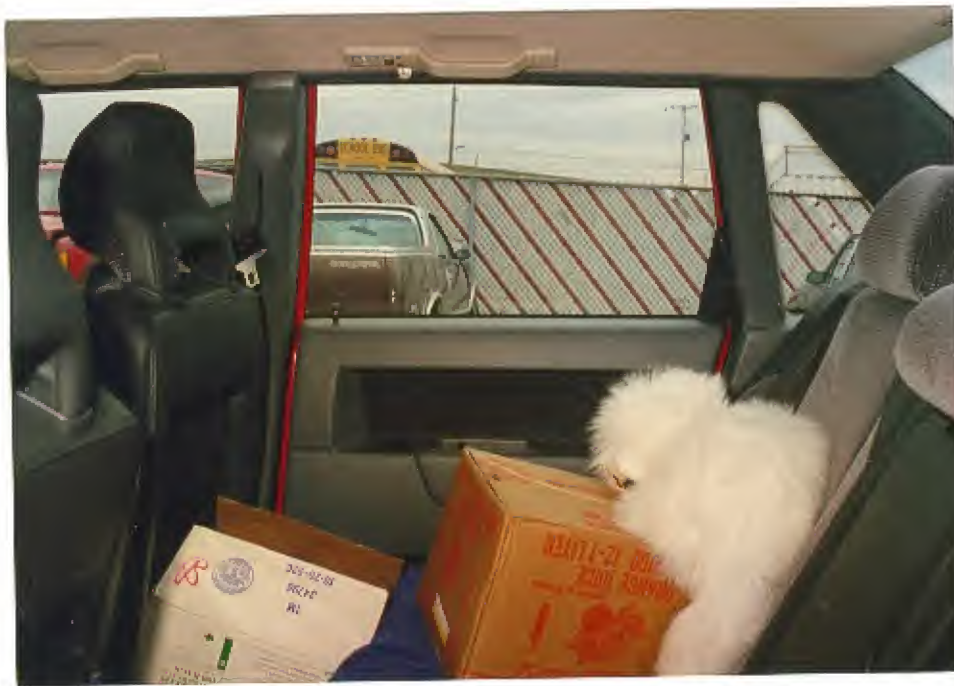
42

Both front seat manual 3-point lap and shoulder belt systems were equipped with pyrotechnical pretensioners that were activated with deployment of the SRS. The pretensioners spool-up belt slack to provide an occupant with a snug belt for maximum protection during a crash. Both front seat belts were not worn by the occupants; therefore, the belts were retracted against the B-pillars as the pretensioners fired. The belt webbing was spooled-up by the pretensioners and, as a result, the webbings were pulled taut against the pillars and were

Right Front Passenger's Manual Belt Locked Against the B-pillar

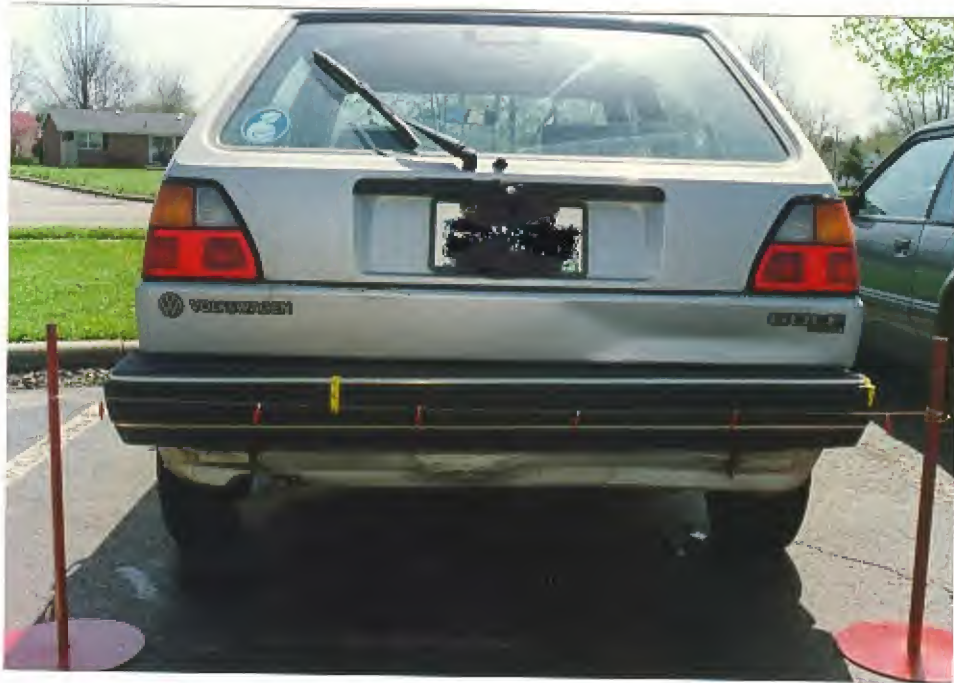
49

The rear area of the Volkswagen Golf sustained minor damage as a result of being struck by the frontal area of the Volvo. The driver/owner reported that the right rear bumper area was previously damaged from an extremely minor backing collision against a tree. He reported that the previous damage had not been repaired.

The Volvo impacted the right two-thirds of the rear area of vehicle #2. Direct contact damage began 31.1 cm (12.3") left of center and extended 105.2 cm 41.4" to the right corner. The contact damage consisted of abrasions to the bumper face and deformation to the sheetmetal panels above and below bumper level. The impact displaced the bumper forward which resulted in a full width induced and direct contact damage length of 150.6 cm (59.3"). Crush values at bumper level were as follows:

Rear Damage to Vehicle #2

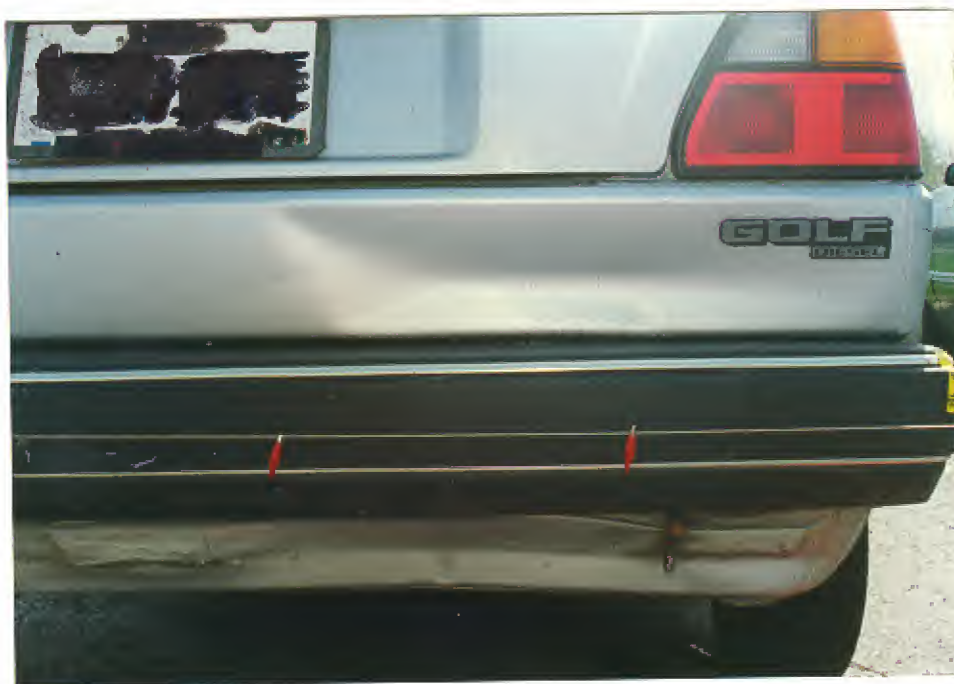
52

Direct Contact Damage Begins 12.25" Left of Center
and Extends 41.4" to the Right Rear Bumper Corner

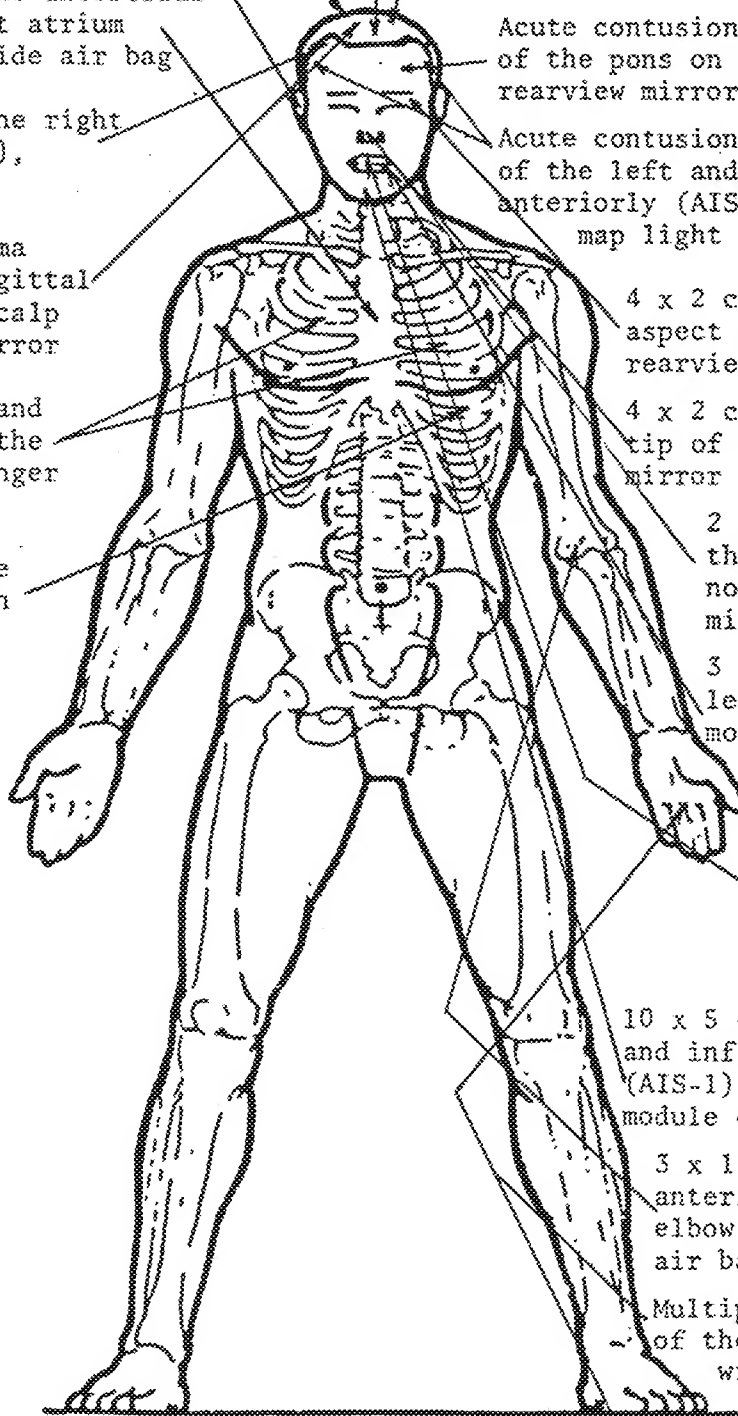
Multiple hematomas of the dorsum of the left hand (AIS-1), windshield

Multiple lacerations (glass cuts) to the dorsum of the left hand (AIS-1), windshield
